TIMBERWISE

Case Study: Sheffield Winter Garden

The Winter Garden is part of Sheffield's 'Heart of the City' project - a £120 million scheme to regenerate Sheffield's city centre. It is the largest temperate glasshouse in a European city centre measuring 70m long, 22m wide with the enormous wooden arches nearly 21m high. The Winter Garden houses tropical plants from across the globe.

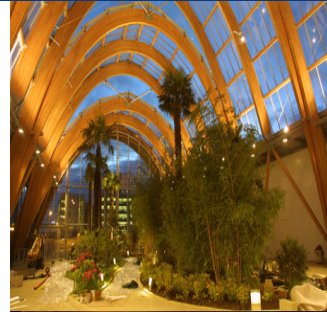
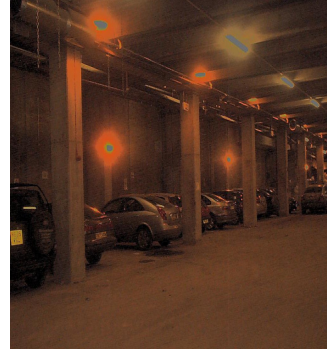
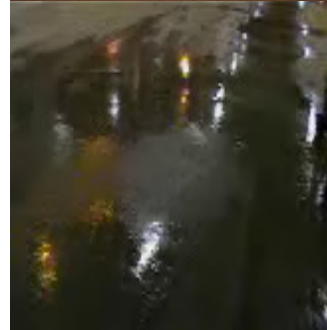
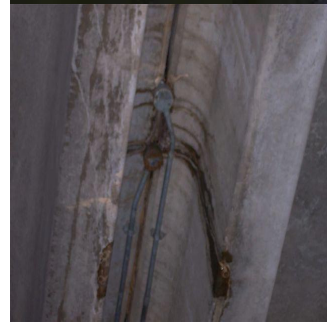
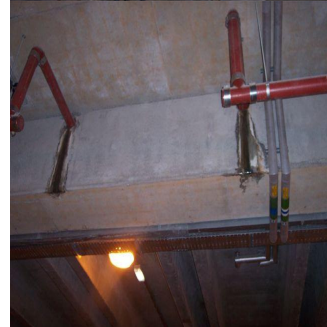
Below the Winter Garden is a car park for visitors and neighbouring businesses. After watering the plants, the excess water was escaping from within the planters beds and falling onto the parked cars in the car park below.

The water problem was caused by insufficient sealing around the joints and drain outlets within the planter beds. The Root Barrier had failed to stop roots from damaging the Bituthene proofing membrane leading to water seepage.

Working alongside Safeguard Chemicals we were able to source a product made by Vandex that would be suitable for sealing around any pipes or wires that passed through the concrete structure. It was also flexible enough to seal any construction joints while still allowing the structure to move.

The end result is that no matter how much watering the exotic plants need the cars below remain dry.
